# MEMORANDUM

**DATE:** August 8, 2020  
**RE:** Site Plan Review for Shoreline Modification  
Raymond & Micki Pollister, 8543 Cairn Hwy, Elk Rapids, MI Parcel: 05-06-015-047-52

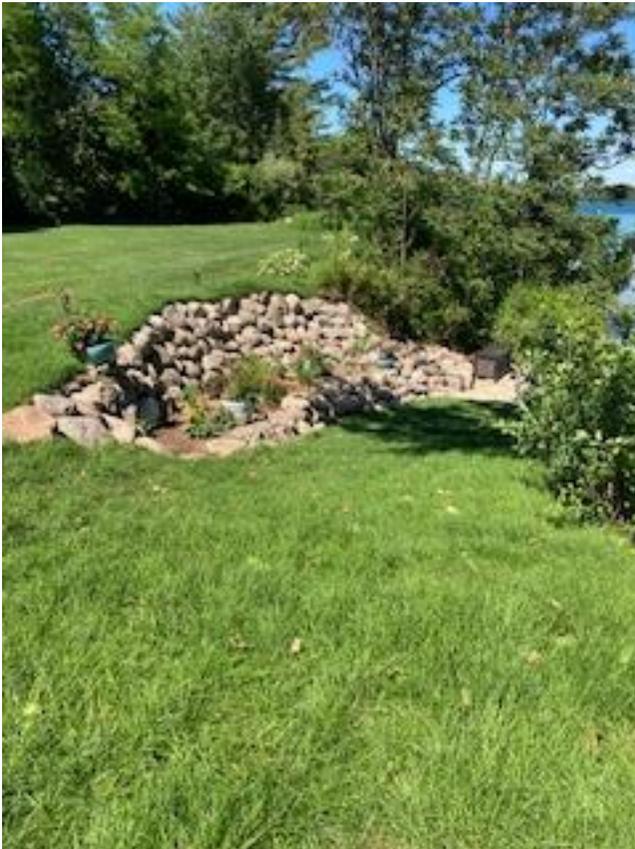
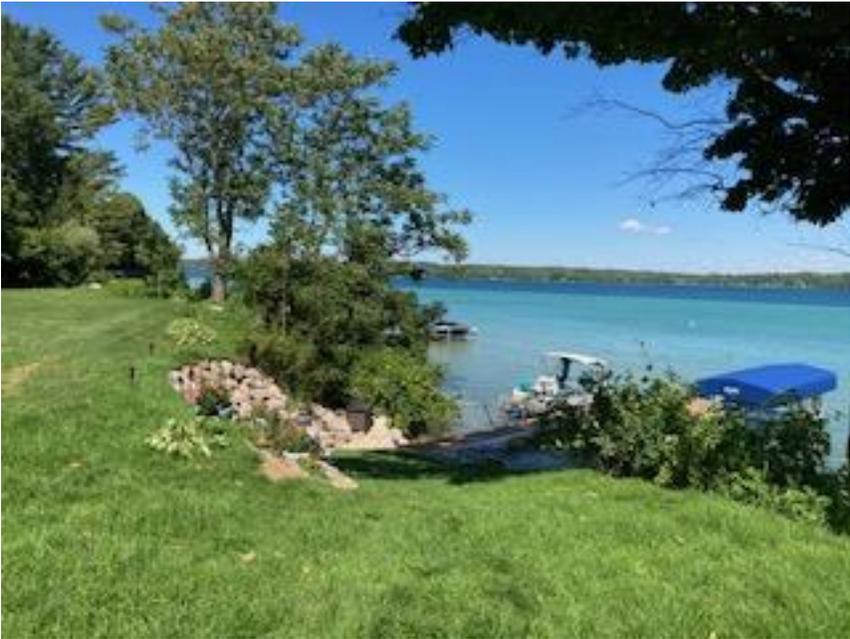
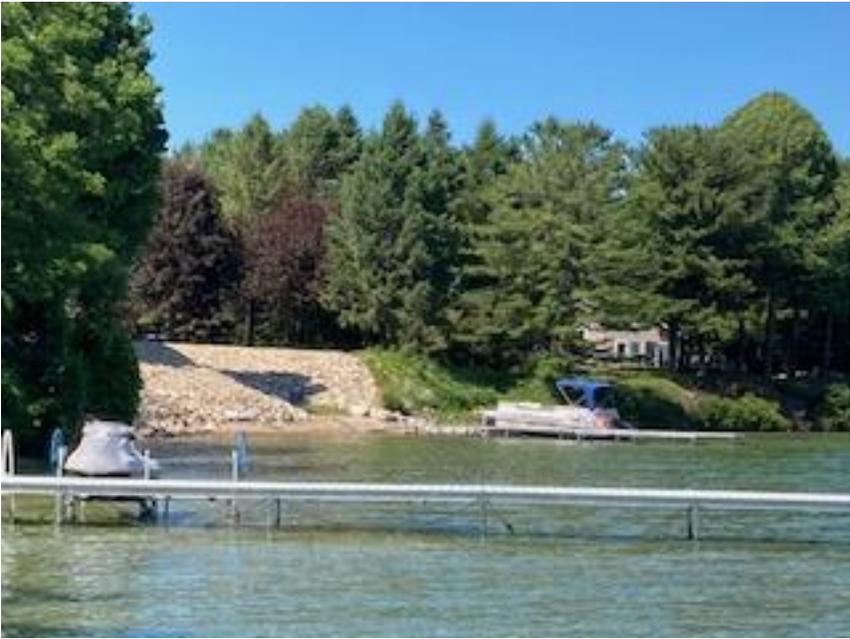
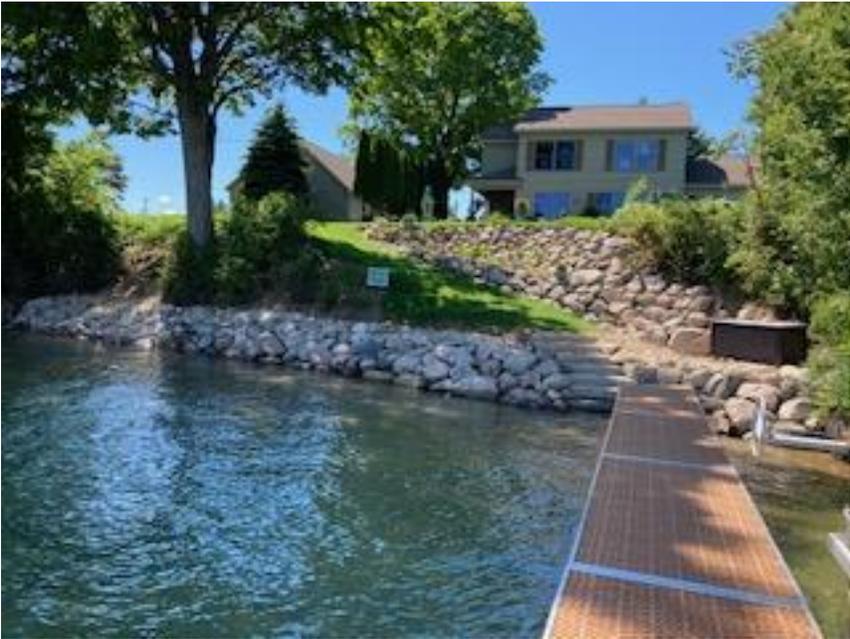
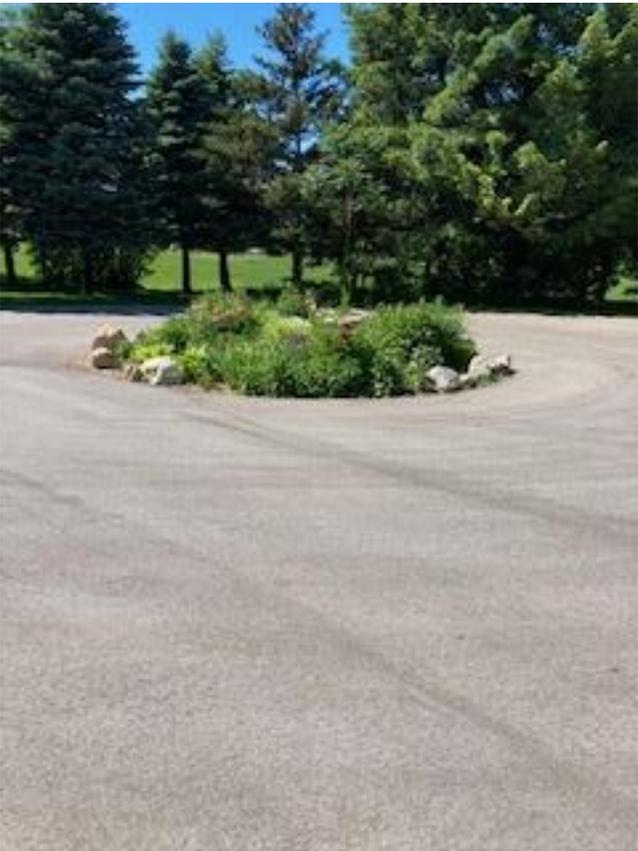
**PICTURES PROVIDED BY HEIDI SHAFFER AS PART OF THE ABOVE EMAIL**

**Comment: The existing regulated shoreline area was primarily shrubs and ground cover and other natural material along the entire length of the shoreline. The bulk of this material has been removed and replaced with rocks. (See Application Photos and Photos provided by Heidi Shaffer)**

I went out to Pollister's site. I was expecting rape and pillage - but was pleasantly surprised. I wish all people did what the Pollisters did. It is beautiful.

As I said before - the plan does absolutely show a walkway from the top of the 15' bank to the bottom of the hill. I like very much what the contractor did - instead of cutting a huge trench into the bank that would have extended at least 30' into the yard to make it walkable, the contractor protected the bank, protected that beautiful tree and maintained all the vegetation on the bank. There are trees on both sides of the riprap protection - dense trees and shrubs that were left. If they had cut the walkway perpendicular to the slope the amount of earth disturbance would have been significantly more. The contractor was responsible and minimized the earth disturbance. As he dug the ramp out - he hauled the dirt off. He didn't leave it on site to risk it compromising the lake.

Micky Pollister has already planted the terrace and it is beautiful ---I also love their rain garden road side of their home.

1. Approve the project as constructed.
2. Approve the project with the condition upland rocks be removed and replaced with suitable vegetation to stabilize the bank and return the bank to a natural condition as it existed previously.
3. Others as deemed appropriate by the applicant.

If the Planning Commission requires restoration of the shoreline to a natural condition with vegetation plantings, it would be appropriate to require a Performance Bond as authorized in Section 2.11.B.3 of the Zoning Ordinance.
